Palmetto Yachting  
Yacht Surveyors, Marine Corrosion Control  
Surveyor-William T. Wernimont  
4711 7th St. Ct. E.  
Ellenton, FL 34222  
(813) 729 - 1970

Type: BISCAY CRUISER Name: FISH TALE II Hull #: MKZ300051082

CORROSION REPORT

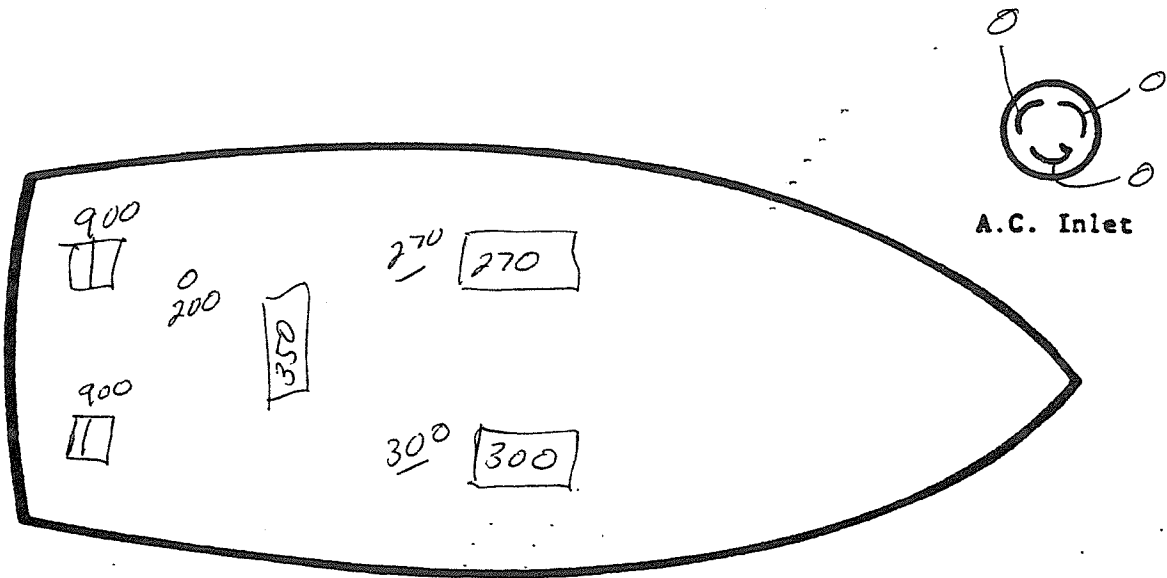
ALL READINGS ARE IN MILLIVOLTS

RESULTS ALL ITEMS ARE NOT BONDED. THE SHAFT  
ZINCS ARE NOT EFFECTIVE - THE RUDDER ZINCS  
ARE GOOD -

A.C. Stray Current Present NO

D.C. Stray Current Present NO

RECOMMENDATIONS MAINTAIN GOOD ZINCS AT ALL  
TIMES - CONSIDER BONDING - IN THE FUTURE.
